RECEIPT DATE: 5/20/19 **ONSITE SEWAGE DISPOSAL SYSTEM** P 565494

PROPERTY ADDRESS: 13930 Kennard Drive

INFORMATION FORM - SEPTIC SYSTEM REPAIR/UPGRADE

Date: March 26, 2019 Name of Evaluator: Adam Brown Time: 11:30 AM Property Address: 13930 Kennard Drive Glenelg, MD 21737 Recent Weather Conditions: Normal		Ordered By: Audrey Bullock Buyers: Nathan Howell Homeowner Interview: The homeowner interview was requested, but was not received prior to the evaluation.		Occupied: <input type="checkbox"/> Yes <input checked="" type="checkbox"/> No Length of Time Vacant: Unknown # of People Living in Home: N/A # of People moving in: 4 Property Age: 1993 System Age: 1993 Last Date of Cleaning: Unknown Recomm'd Pumping Freq: 1-2 Years	
Liquid level in tank is: <input type="checkbox"/> Above Normal <input checked="" type="checkbox"/> Normal <input type="checkbox"/> Below Normal		Bottom Solids Depth: 12 Inches		Depth of tank: 14 Inches	
Depth of tank: 14 Inches		Type of Tank Access: 6" PVC Cleanout		Depth of tank access: At Grade	
Maintenance appears: <input type="checkbox"/> Good <input checked="" type="checkbox"/> Fair <input type="checkbox"/> Poor		Depth to Distribution Box: 33 Inches		Efflue

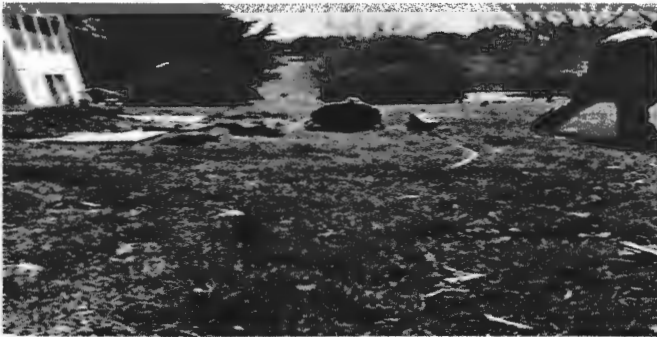
Picture 1:

Shows an electrical wire that appears to be located in close proximity to the septic system and may be located over the back line. In the event of future repairs, caution should be used when excavating.

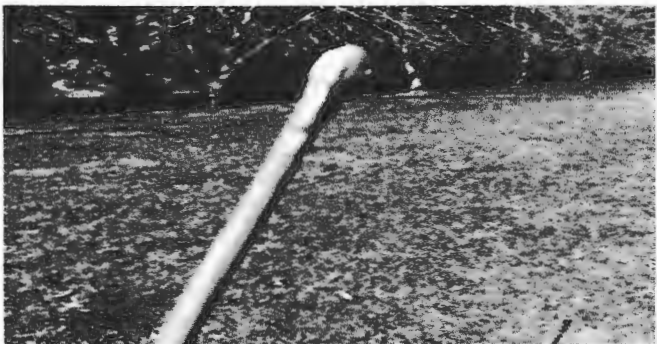
Picture 3:

Shows the probe to be saturated after probing drainfield A.

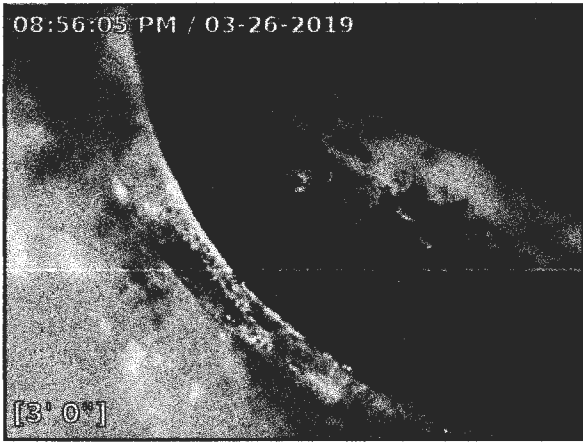
3/26/2019 8:56:05 PM 3' 1"
Shows what appears to be a break in the PVC front line slightly past the joint in the line. This will need to be remediated by a license contractor.

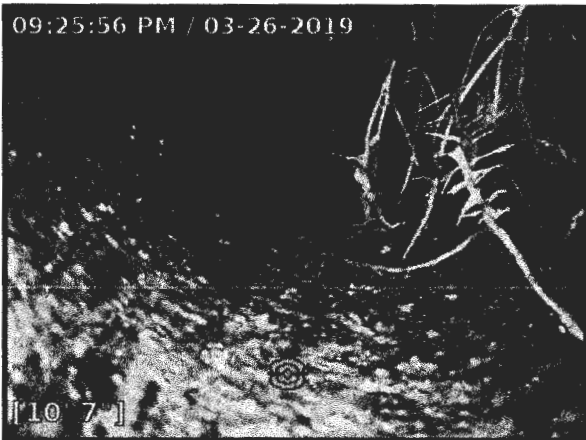
Shows a break in the line in the solid portion of line in drainfield line B. This will need to be remediated by a license contractor. Shows minor root intrusion in drainfield line B.

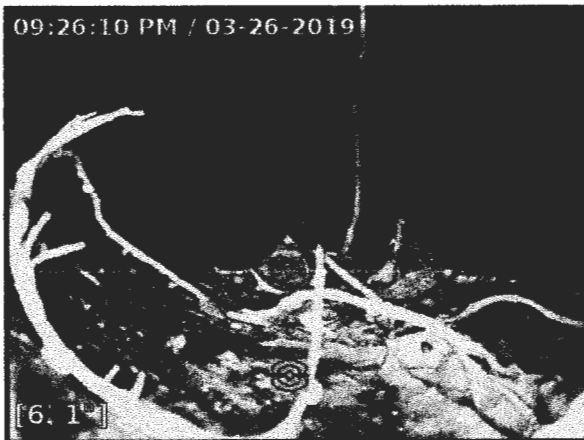
Shows a break in the line in the solid portion of line in drainfield line B. This will need to be remediated by a license contractor.
