From: Williams, Jeffrey
Sent: Tuesday, July 02, 2019 3:17 PM
To: 'Speed Raycer'
Subject: RE: 3134 Brookmede Septic Information

3134 Brookmede Road
Septic System Failure Information

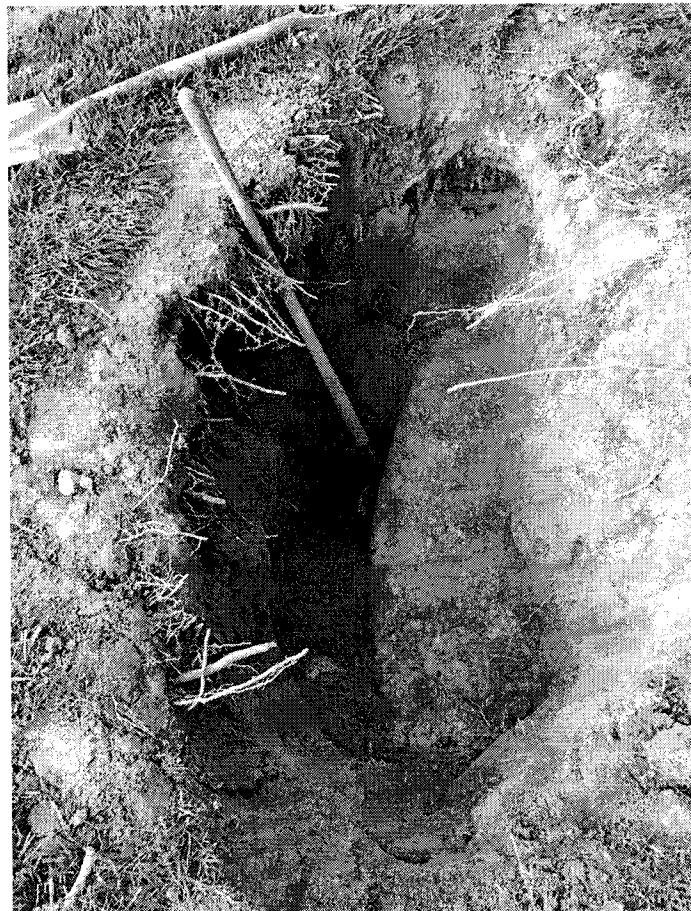
- The structure is a dry well consisting of a concrete lid approximately 12 ft diameter on stacked cinder block walls (depth unknown).
- The system has failed from infiltration induced migration of soil into the dry well through gaps in the block walls. This has resulted in the sinkhole and filling of the well. In addition to the sinkhole there is depressed ground around other portions of the perimeter and the condition is actively worsening.

Exposed concrete top of dry well

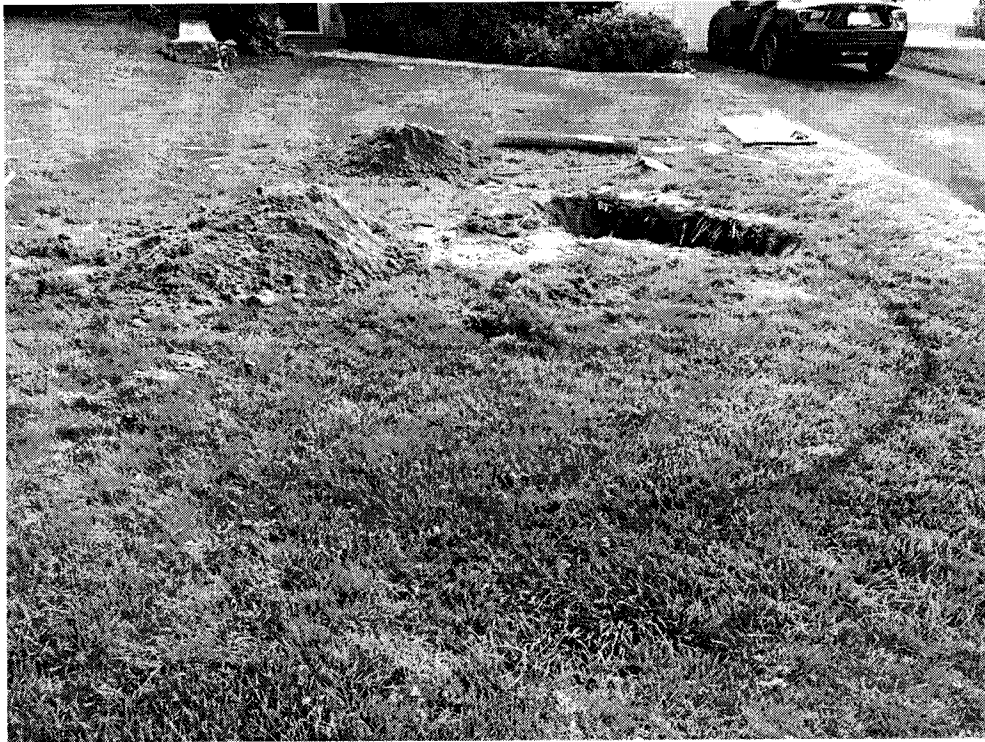
Mr Glock: Seeing the photo of the lid I think is enough to verify that what we saw was the drywell. The fact that there are the sinkholes around it is enough to say the drywell is in danger of possibly collapsing at some point and is failing for purposes of grant eligibility.

Red ring shows limits of dry well (note depression in foreground at perimeter)

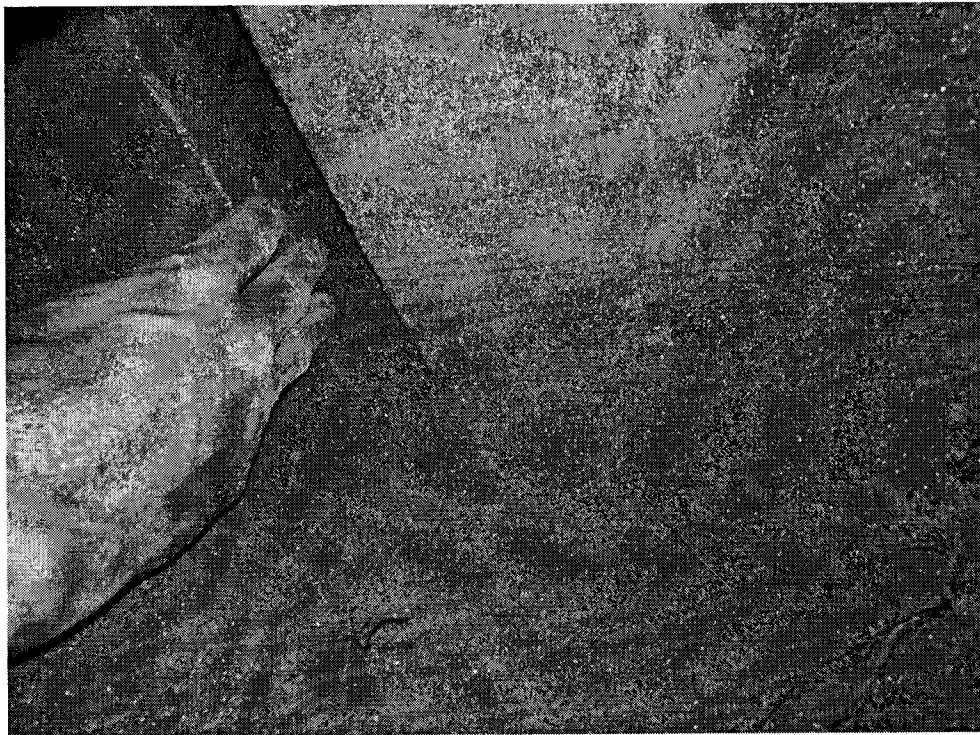
Outside of block wall at joint between blocks
