RECEIPT DATE: 1/7/21 **ONSITE SEWAGE DISPOSAL SYSTEM** P 572914

APPROVAL DATE: 1/19/21 (ST) **PERMIT:** **REPAIR** A _____

PROPERTY ADDRESS: 3663 Jennings Chapel Road

Date: October 26, 2020 Name of Evaluator: Scott Thompson Time: 10:15 Property Address: 3663 Jennings Chapel Road Woodbine, MD. 21797 Recent Weather Conditions: Rain	Ordered By: Brian Camley Buyers: Brian Camley Homeowner Interview: The homeowner interview was sent but not received prior to the evaluation.	Occupied: <input checked="" type="checkbox"/> Yes <input type="checkbox"/> No Length of Time Vacant: N/A # of People Living in Home: Unknown # of People moving in: 2 Property Age: 1972 System Age: 1972 Last Date of Cleaning: Unknown Recomm'd Pumping Freq: 1-2 Years
Liquid level in tank is: <input type="checkbox"/> Above Normal <input type="checkbox"/> Normal <input checked="" type="checkbox"/> Below Normal	Bottom Solids Depth: 14 Inches	
Depth of tank: 41 inches	Type of Tank Access: 6-inch Cleanout	Depth of tank access: At Grade
Maintenance appears: <input type="checkbox"/> Good <input checked="" type="checkbox"/> Fair <input type="checkbox"/> Poor	Depth to Distribution Box: N/A

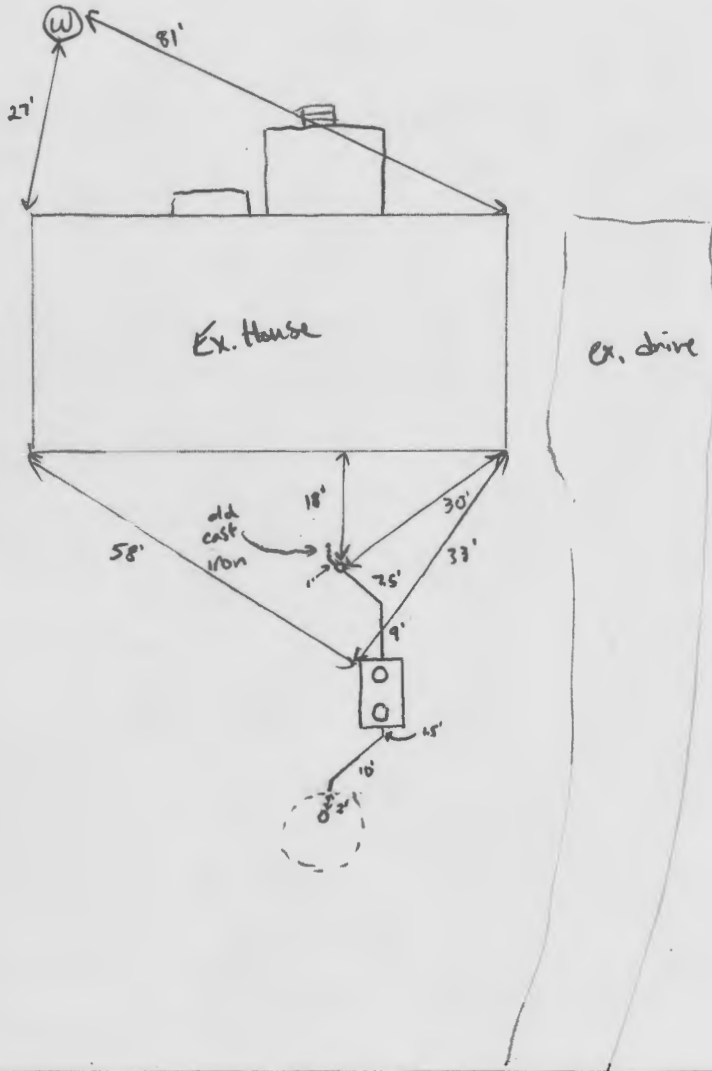
01/15/2021 MOVED NEW TANK LOCATION BTWN EXISTING AND DW TO MANAGE COVER AND NOT IMPACT BX TRENCH. EX DW IS COMPLETELY DRY. MAKE SURE TANK DELIVERY DOES NOT GO OVER DRY WELL. (H)

1/19/2021 New 1500 gal septic tank installed and connected via ferroc to old cast iron line coming out of the house. Connected into existing drywell. (SI)

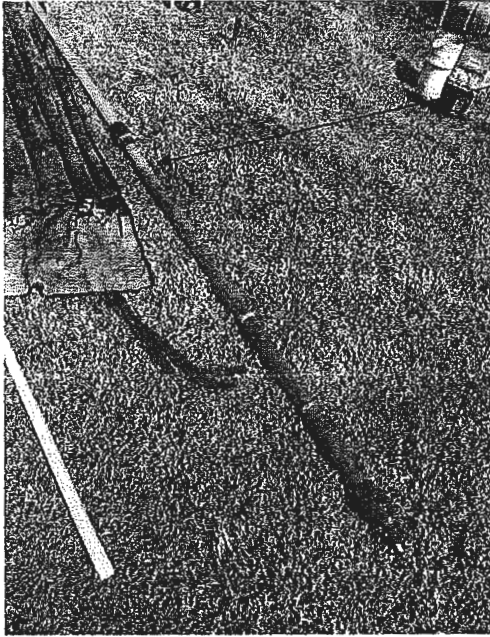
Picture 1:

Picture shows the effluent level upon arrival.

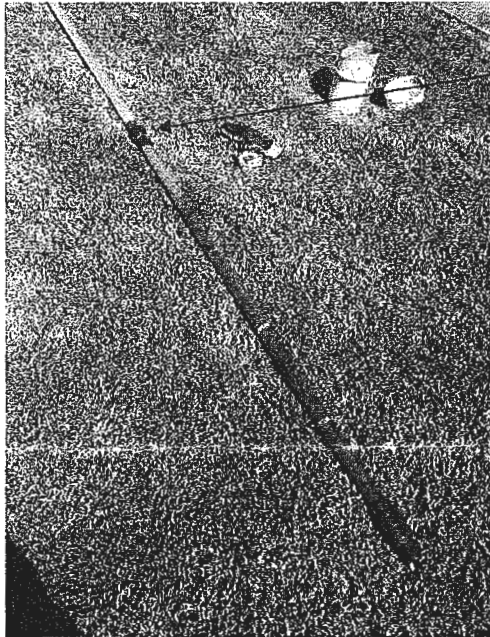
Picture 2:

Picture shows the effluent level after filling the tank. The effluent level was measured at 61 inches of effluent.

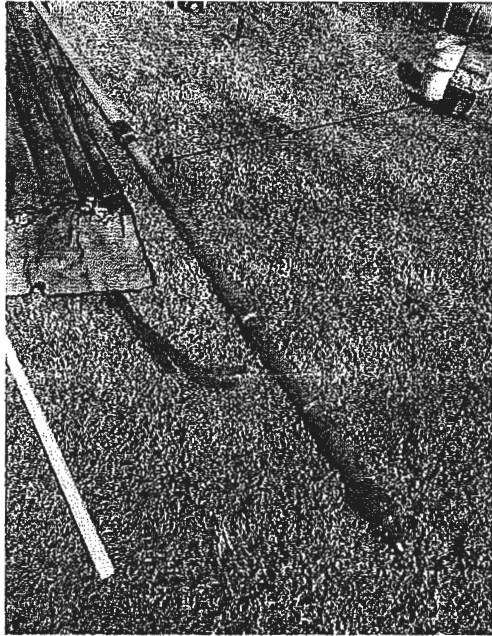
Picture 1:

Picture shows the effluent level upon arrival.

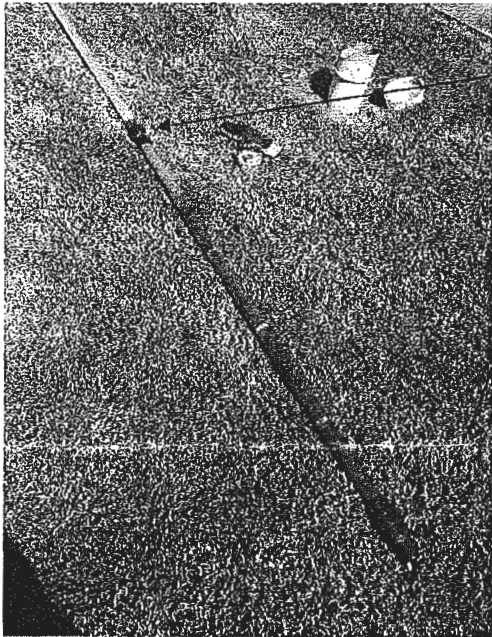
Picture 2:

Picture shows the effluent level after filling the tank. The effluent level was measured at 61 inches of effluent.
