Re: 8022 McKenstry Dr
Laurel, MD 20723

On December 1, 2022 BAT Onsite, LLC was called by Darrell Kelly from HGHI Contractor Corporation to locate and evaluate the Onsite Wastewater System that serves the above referenced property. The following is the information we discovered:

8022 McKenstry Dr.
Septic Layout

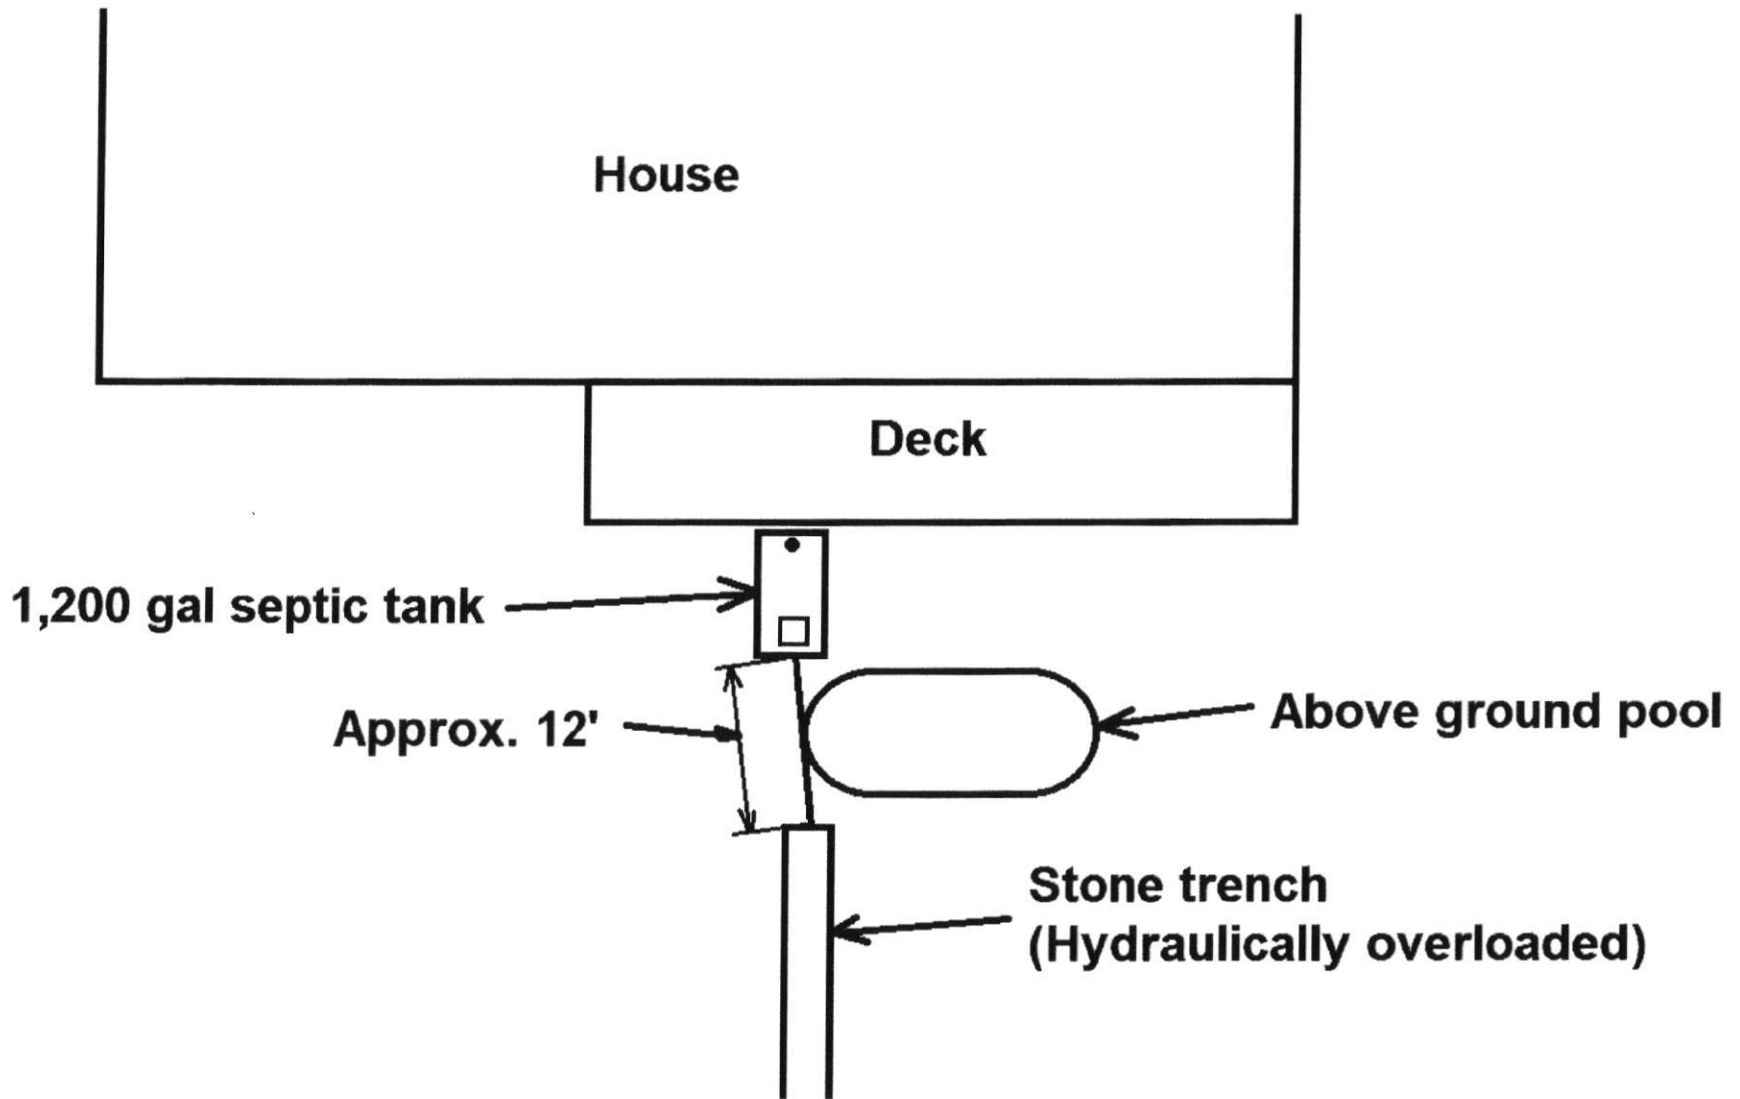
- The Onsite Wastewater System is located in the back yard
- The septic tank is about 1' out from the edge of the deck, approximately midway in relationship to the length of the back of the house. Based on dimensions taken and my experience with local precasters, the tank is a mid-seam 1,200 gal concrete tank.

- The liquid level in the tank was approximately 5" above the normal operating level.
- There is an above ground pool placed 2' from septic tank and about 3' from beginning of drainfield trench.

- There was a 4" SCH 40 "T" outlet baffle installed in the tank with approximately 12' of Sch 40 pipe feeding one drain field trench.
- The drain field trench was hydraulically overloaded, the perforated pipe had been installed with the drain holes turned up, and there was no sign of a paper barrier or any other soil to stone barrier covering the stone.

- The septic tank is too close to a permanent structure on the house. A septic tank is required to be at least 10' from the outside wall of a house, or any porch or deck.
- The above ground pool is located too close to the Onsite Wastewater System. Any pool is required to have a 20' separation distance from any part of the Onsite Wastewater System (unless the County administers a variance).
- The drainage trench is currently overloaded. This generally means that the system has failed and needs to be replaced. There can be other causes for this condition, for example:
 - leaky fixtures (toilettes, faucets, etc.)
 - water treatment systems
 - heavy domestic uses (laundry, bathing, etc.).

It is the opinion, by this inspector, that the trenches are failed due to age and need to be replaced.

To repair/replace the existing system someone (BAT Onsite, LLC or others) will have to obtain a Septic Repair Permit from Howard County. Howard County is the authority to direct corrective measures to be taken. After the permit is administered, typically, we would schedule a "Perc" test and soil evaluation with Howard County. Howard County would then give us the design criteria to design the system repair. BAT Onsite would then prepare a design drawing and submit this drawing to Howard County Health Department. After the design is approved by the Howard County Health Department, BAT Onsite can then give the customer a firm price for the repair of the Onsite Wastewater System.
