HOWARD COUNTY HEALTH DEPARTMENT

October 5, 1987

RE: Percolation Testing-Repair
Proposed Addition to
Septic System
11865 Lime Kiln Road

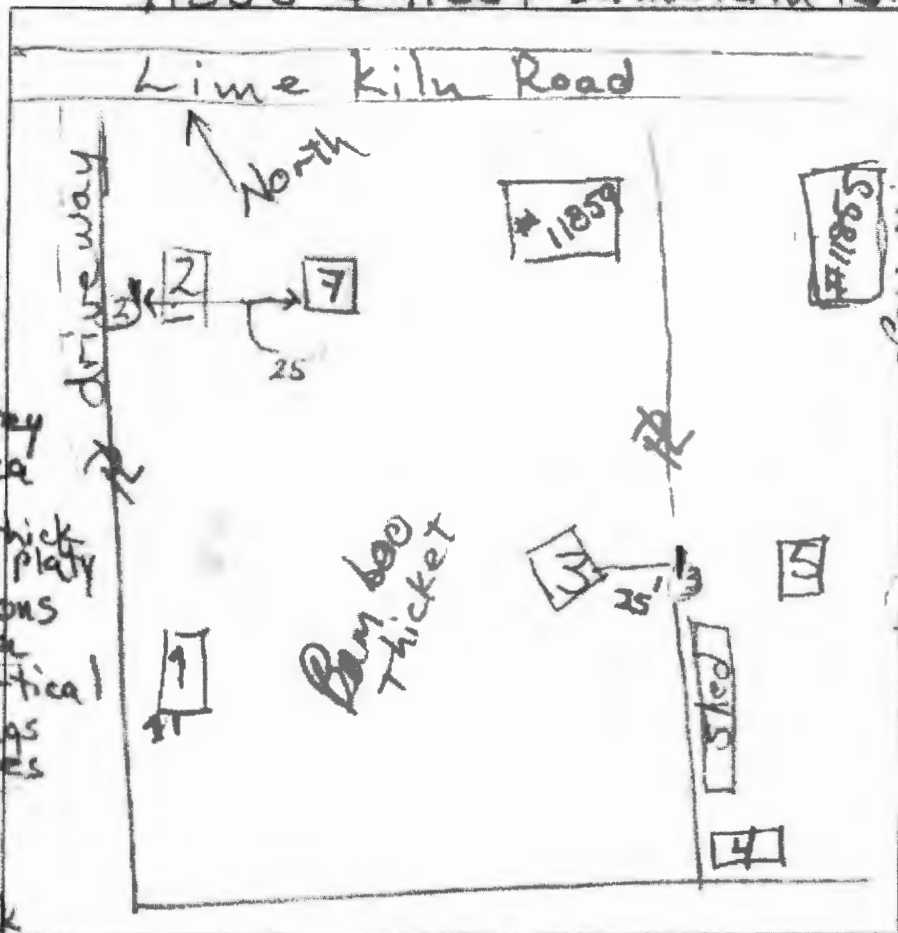
1
dk brn L
3 v f sbk
pale brn L
2 f sbk
red-yel L
3 m sbk
few mica
2
white and gray
sl, many mica
3.5
yel-red sl, thick
many fine platy
white striations
many mica
14
white coatings
on ped faces

2
dk brn L, 2 v f sbk
dk brn & brn L
2 f sbk

4
yel brn L
coarse prismatic
red-yel
& yel-brn
L & sl, dense
23 p (pale yellow)

5.5
red-yel & white
sl thick platy
many mica

9
yel-red sl
many mica
water seeps
yel-red sl
moist, sticky

DATE	TEST #	DEPTH	START	BREAK 1" DROP	STOP 2" DROP	TIME OF 2ND INCH	P/F/H
8/26/15	1	5.7/105	2:04	2:06	2:09	3	P
8/26/15	2	4.2/89	2:56	3:46			F
8/26/15	3	6.5/105	3:20	3:27	3:35	8	P
8/26/15	7	105	Visual	3'-6.5' sidewall	1.2 gpd/G2		P
* Observed water table in other locations and collapse of shell at #1 may indicate presence of saturated soils at location #1 approx. 28' - 5.8' - 14' - 11'

dk brn L
3 v f sbk
dk brn & brn
L, 2 f sbk
dk, brn, brn
& yel-red
coarse
14
prismatic
yel-red L
coarse prismatic
25
red-yel sl
v. coarse prismatic
brn clay skins
on ped faces
dense, coarse
mica
5
red-yel ls
thick platy
many mica
thick white
coatings on
ped faces
6
yel-red
ls, thick platy
many mica
thick white
coatings on
ped faces
11
water seep

2
dk, gray-brn
to dk, brn L
brn & red-yel L
coarse prismatic
red-yel & brn
sl, coarse prismatic
28
red-yel & white
sl, thick platy
many mica
5.8
yel-red ls
thick platy
many mica
11
water seep

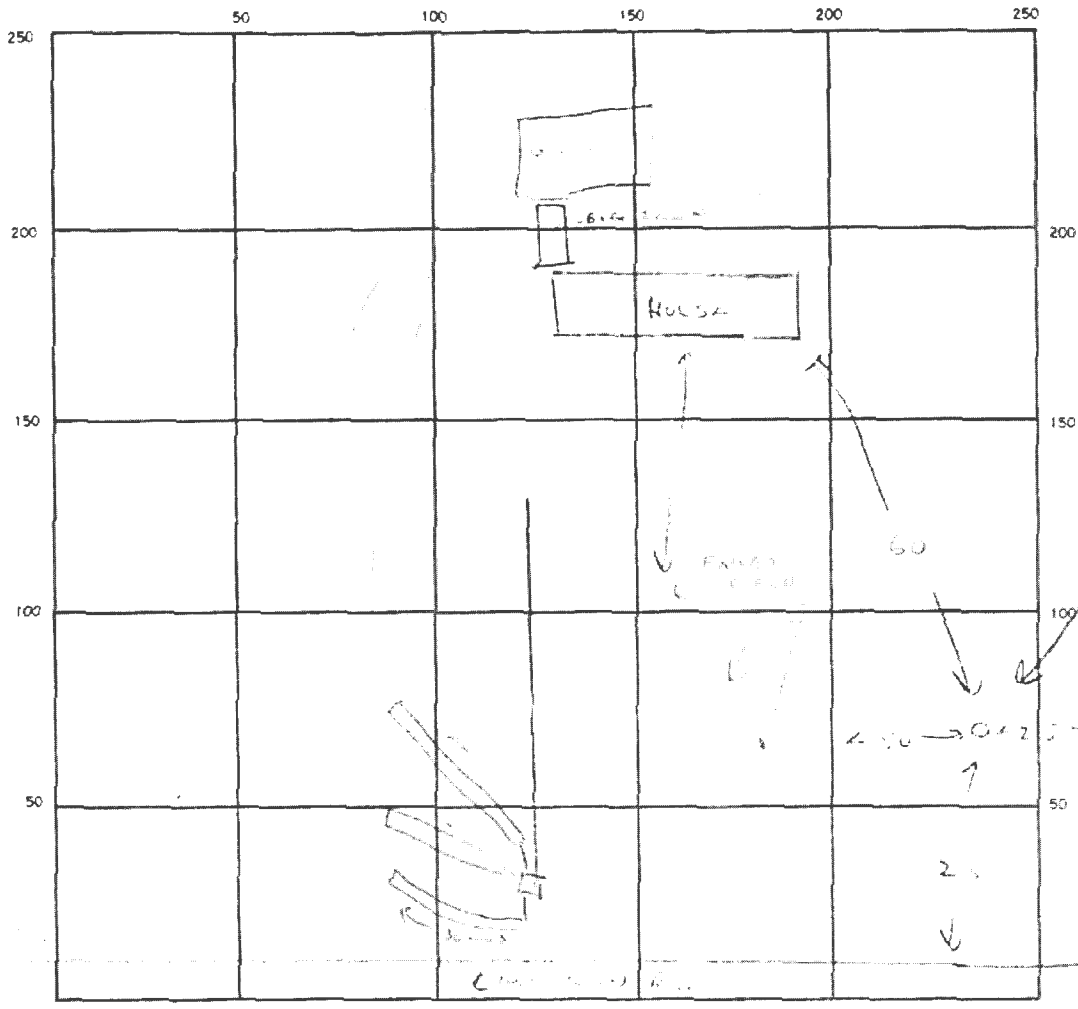
PLOT PLAN

REMARKS 5/1/22 REPAIRS TO SEPTIC TANK AND DRAIN FIELD

TO REPAIR SEPTIC TANK AND DRAIN FIELD, THE EXISTING TRENCHES WERE OPENED UP AND THE GRAVEL WAS REPLACED WITH NEW GRAVEL.

THE SEPTIC TANK WAS FOUND TO BE IN GOOD CONDITION AND NO REPAIRS WERE NEEDED.

THE DRAIN FIELD WAS FOUND TO BE IN GOOD CONDITION AND NO REPAIRS WERE NEEDED.

DIAGRAM
WILLIAM REED
INCORRECT
11/10/88
