RECEIPT DATE: 5/20/19 **ONSITE SEWAGE DISPOSAL SYSTEM** P 565494

PROPERTY ADDRESS: 13930 Kennard Drive

INFORMATION FORM - SEPTIC SYSTEM REPAIR/UPGRADE

Date: March 26, 2019 Name of Evaluator: Adam Brown Time: 11:30 AM Property Address: 13930 Kennard Drive Glenelg, MD 21737 Recent Weather Conditions: Normal		Ordered By: Audrey Bullock Buyers: Nathan Howell Homeowner Interview: The homeowner interview was requested, but was not received prior to the evaluation.		Occupied: <input type="checkbox"/> Yes <input checked="" type="checkbox"/> No Length of Time Vacant: Unknown # of People Living in Home: N/A # of People moving in: 4 Property Age: 1993 System Age: 1993 Last Date of Cleaning: Unknown Recomm'd Pumping Freq: 1-2 Years	
Liquid level in tank is: <input type="checkbox"/> Above Normal <input checked="" type="checkbox"/> Normal <input type="checkbox"/> Below Normal		Bottom Solids Depth: 12 Inches		Depth of tank: 14 Inches	
Depth of tank: 14 Inches		Type of Tank Access: 6" PVC Cleanout		Depth of tank access: At Grade	
Maintenance appears: <input type="checkbox"/> Good <input checked="" type="checkbox"/> Fair <input type="checkbox"/> Poor		Depth to Distribution Box: 33 Inches		Efflue

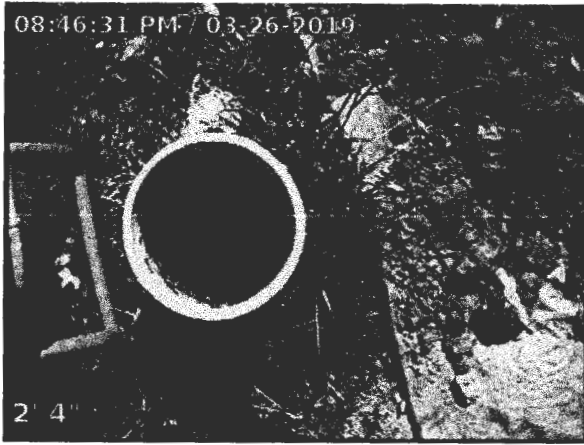
3/26/2019 8:46:31 PM 2' 4"
The camera was introduced into the PVC front line via a 6" PVC cleanout at grade over the front of the septic tank.

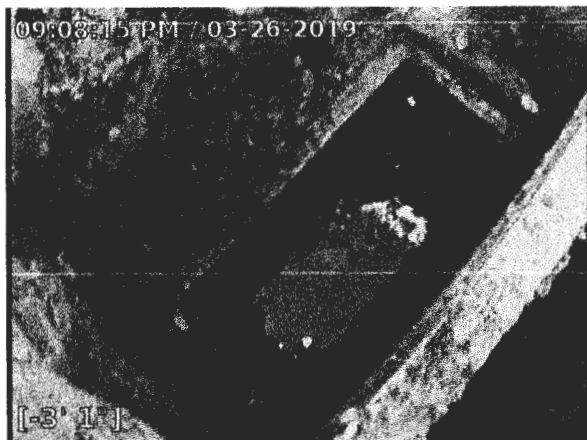
3/26/2019 9:08:15 PM
Shows an excavated distribution box was used to introduce the camera into each of the drainfield lines. Shows there to be 3 drainfield outlets in the excavated distribution box.
