From: Williams, Jeffrey
Sent: Tuesday, July 02, 2019 3:17 PM
To: 'Speed Raycer'
Subject: RE: 3134 Brookmede Septic Information

3134 Brookmede Road
Septic System Failure Information

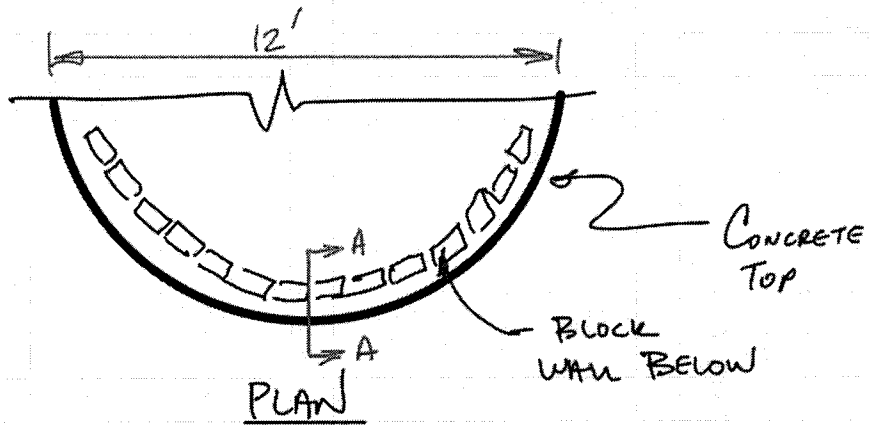
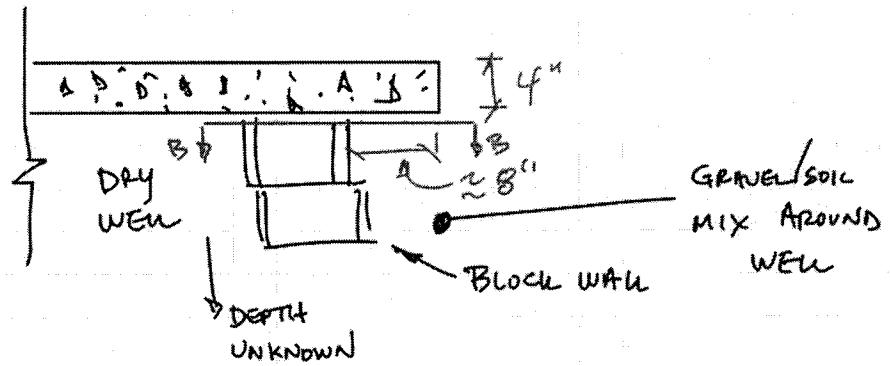
SECTION A-A

- The structure is a dry well consisting of a concrete lid approximately 12 ft diameter on stacked cinder block walls (depth unknown).
- The system has failed from infiltration induced migration of soil into the dry well through gaps in the block walls. This has resulted in the sinkhole and filling of the well. In addition to the sinkhole there is depressed ground around other portions of the perimeter and the condition is actively worsening.
