SITE INSPECTION SHEET

ADDRESS: 4705 MANOR LN CONTRACTOR: N/A

PROPOSAL: Support BO0150880 / NEED SEPTIC NOTES & Soil profile
STORAGE SHED / SHOP W/ NO BATHROOMS
(two bedroom)

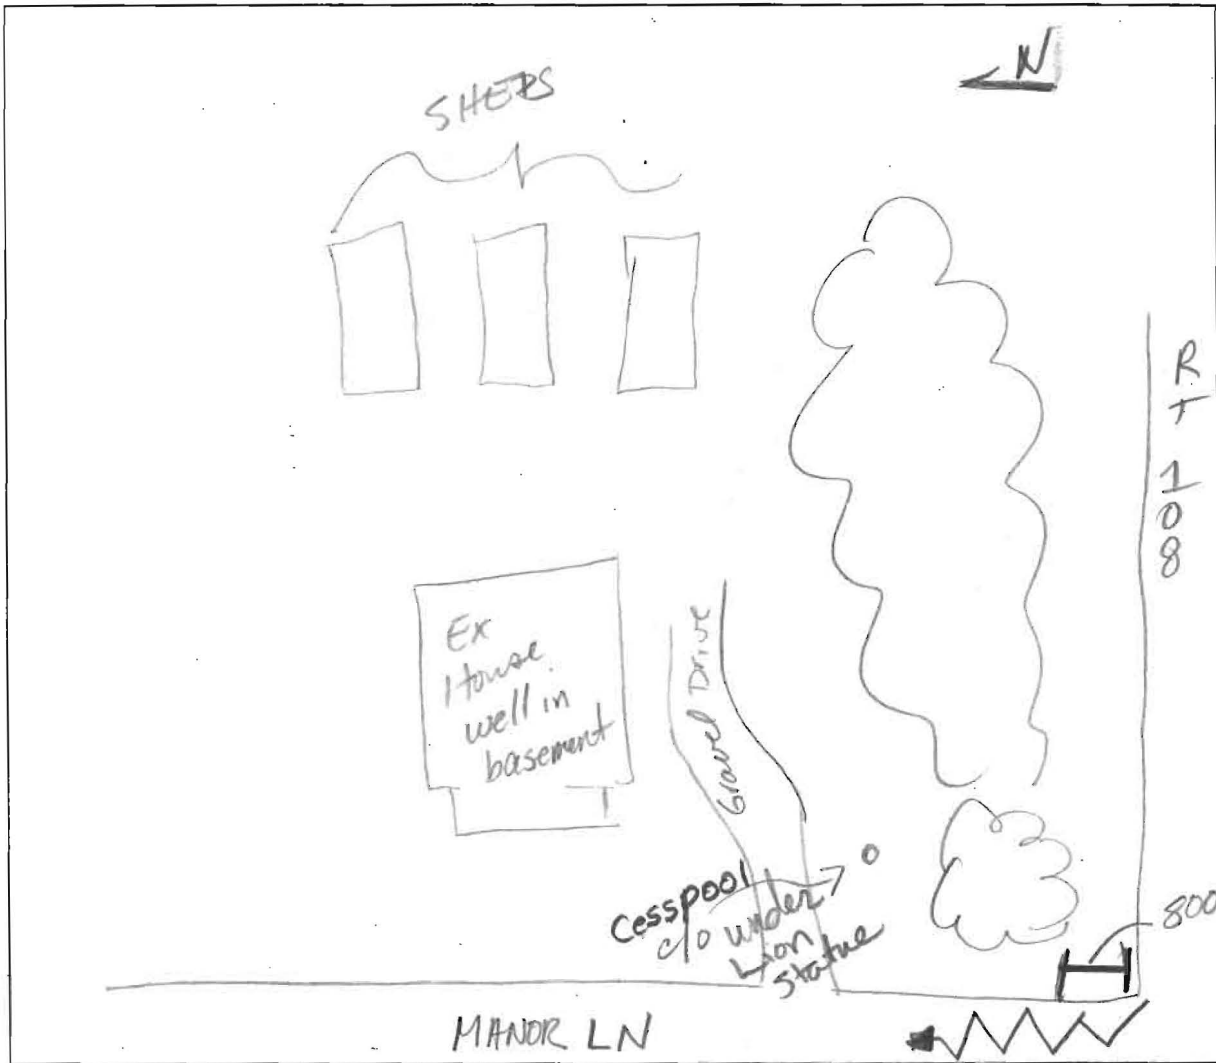
LOCATION DIAGRAM

COMMENTS: 11-13-04 Septic tank full to grade. Need repair Well is in the basement. Tyock to call to schedule repair.

- ① NEED Potable well & septic ON PLAN
- ② NEED TO UNCOVER CLEANOUTS OF S.T. & dry well to verify effluent levels @ insp. adequate

SEPTIC REPAIR

DONE

-OR-
Have septic contractor inspect system & pump tank / send department of pumping S. Tank
